**EAST TOBA RIVER AND MONTROSE CREEK HYDROELECTRIC PROJECT  
INDEPENDENT ENVIRONMENTAL MONITOR TOBA VALLEY WEEKLY REPORT  
JULY 10 – JULY 16, 2010**

DFO File Numbers: 08-HPAC-PA2-00008, 04-HPAC-PA1-000-000061  
Water File Number: A2005412

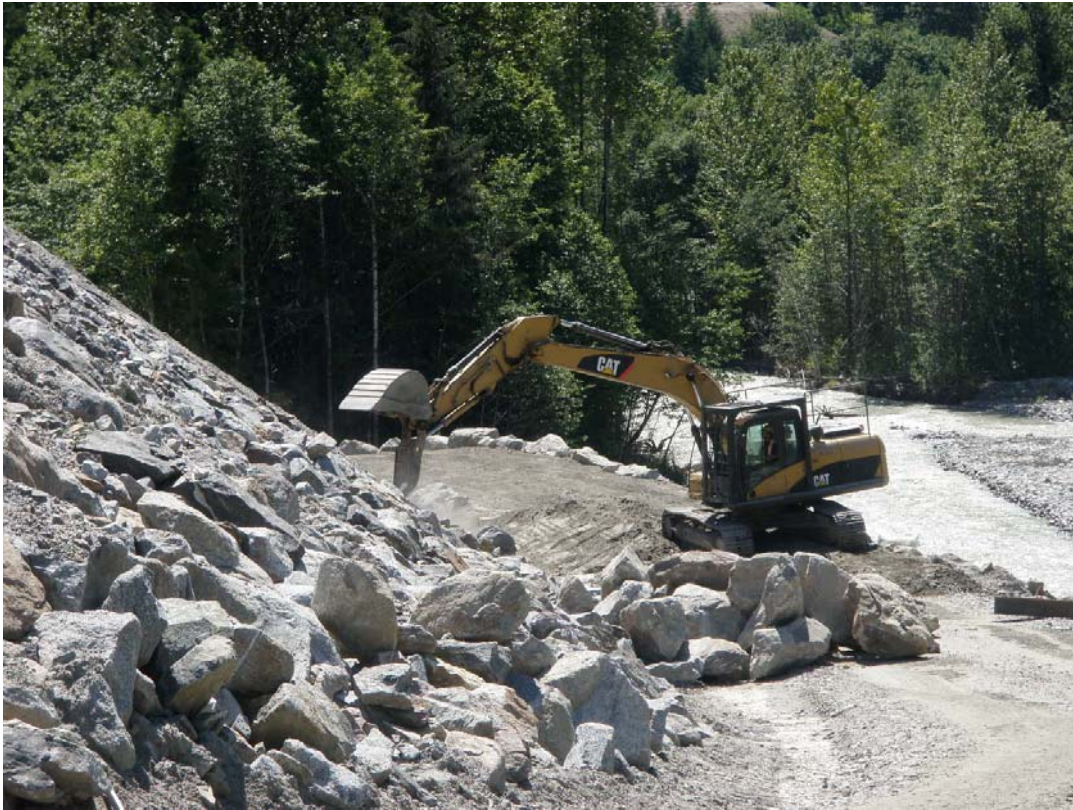
July 10 Ran units 1 and 2 (13m<sup>3</sup>/s each), conducted 400hr test, produced power. Sloped, ditched and placed armour along the tailrace access road. (Photo 1) Ditched and pulled back material at 1+500. Reclaimed PR 2I (2+000).

Sloping, ditching and placing armour along the East Toba tailrace access road. (July 10, 2010 12:02)

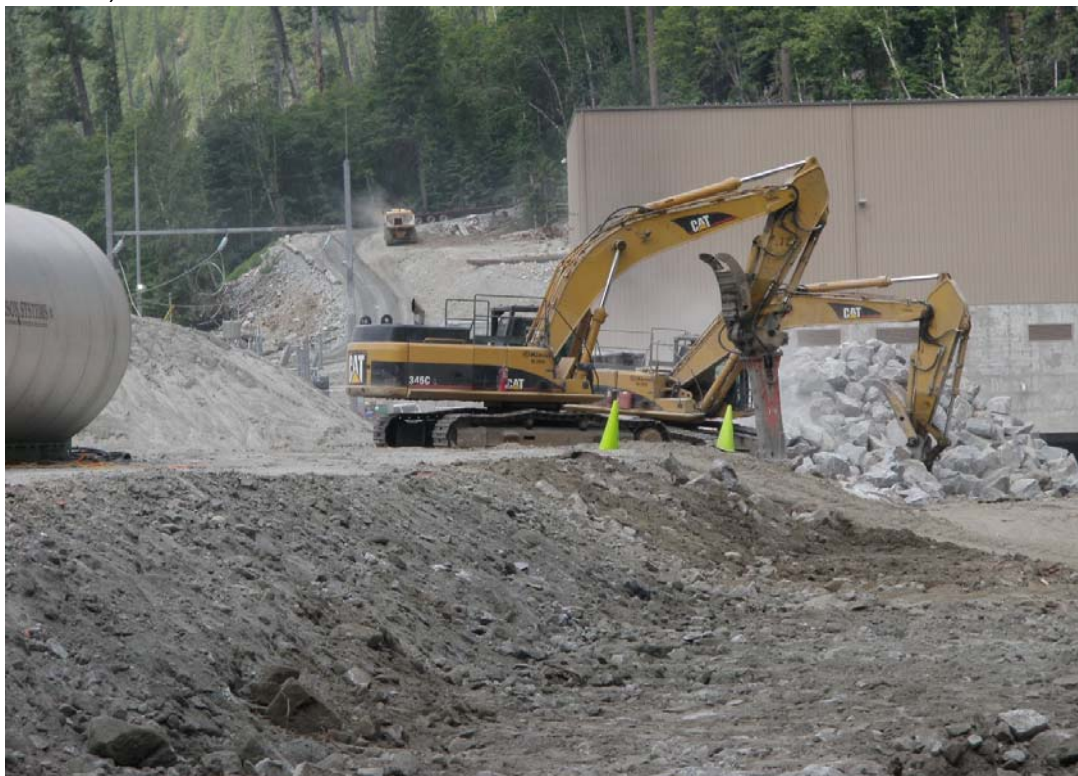
(Photo 2) Breaking and stock piling riprap at the Montrose powerhouse. (July 11, 2010 12:25)
